Idea of Restoration

Sticking the restoration  
Process (Restrictions)

1) Relevée (Surveying) + 2) Restitution (Preparation of the project) + 3) Physical intervention (Restoration)

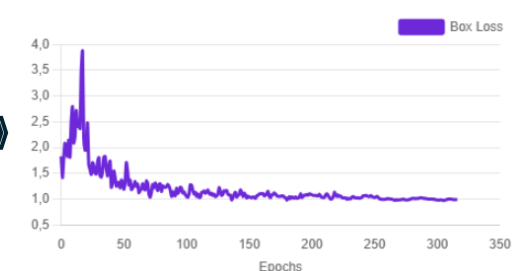
Box Loss

Training Step  
Loss Calculation (from Head Outputs)

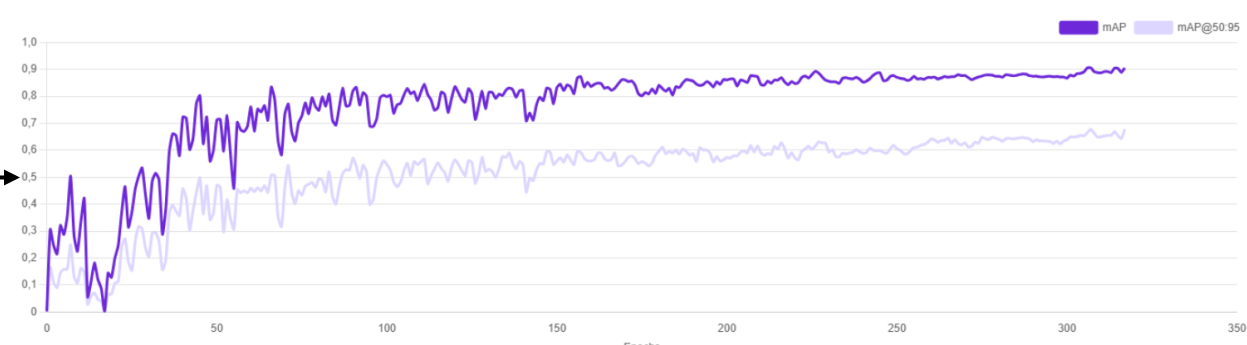
Model Performance

Validation Step

Head Predictions vs Ground Truth
